# **HAZARDOUS MATERIALS SURVEY for 2026 DEMOLITION and REMODEL**

Sweet Home High School  
Sweet Home, Oregon

## Hazardous Materials Survey

**SURVEY SCOPE****Kelsay Project # 1641**

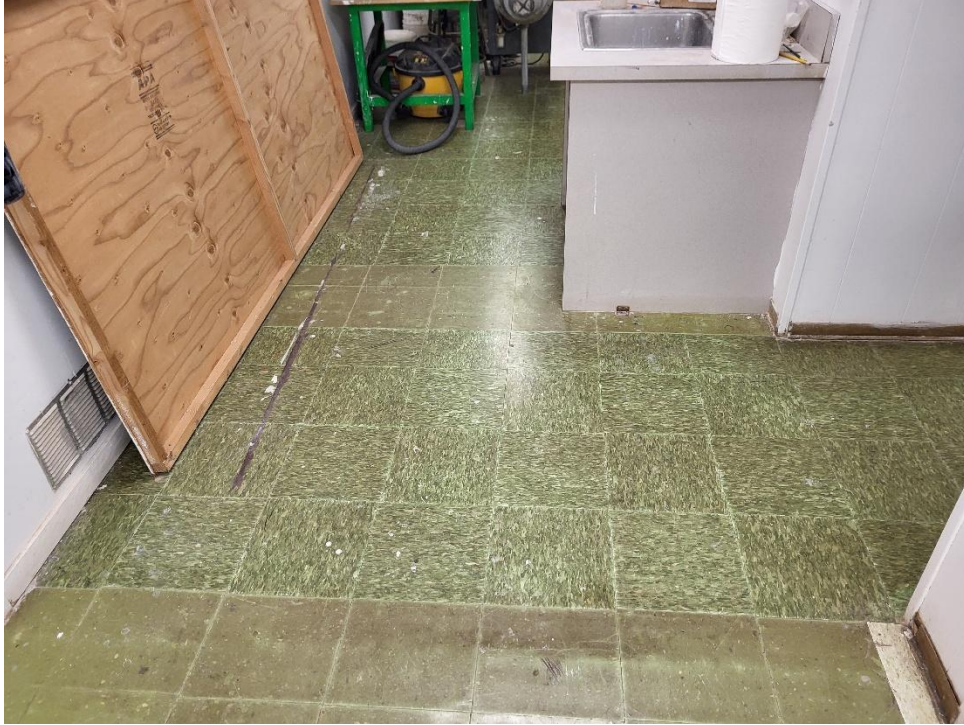
Photo 1 – D5: 12"x12" Green Vinyl Floor Tiles with Black Mastic = 3% Chrysotile Asbestos

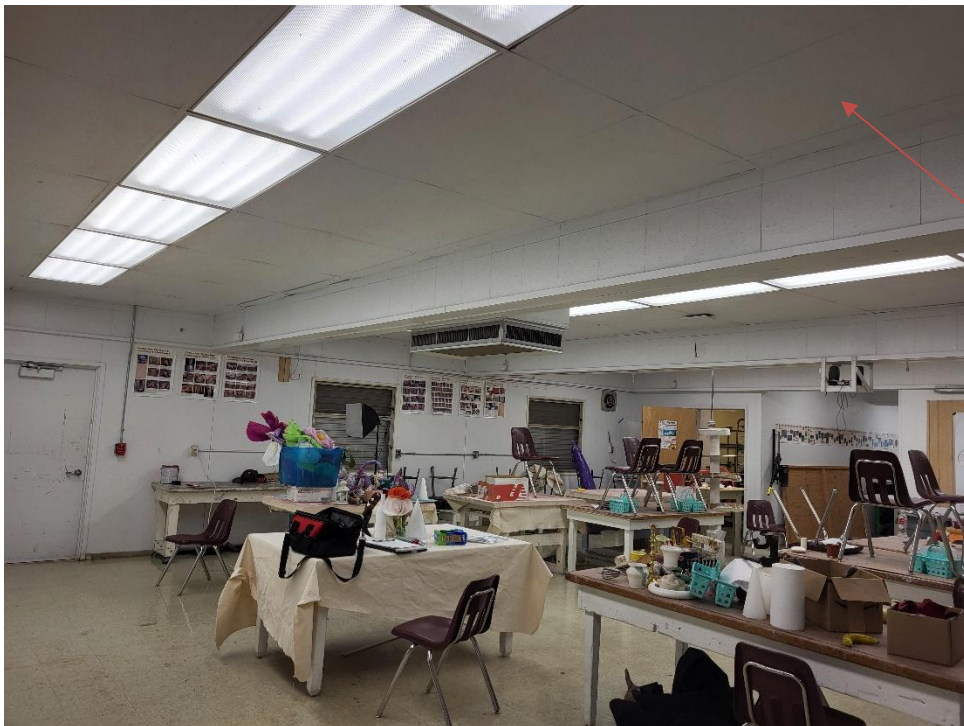
Photo 2 – D5: 2'x4' Drop Ceiling Tiles = 2% Chrysotile Asbestos

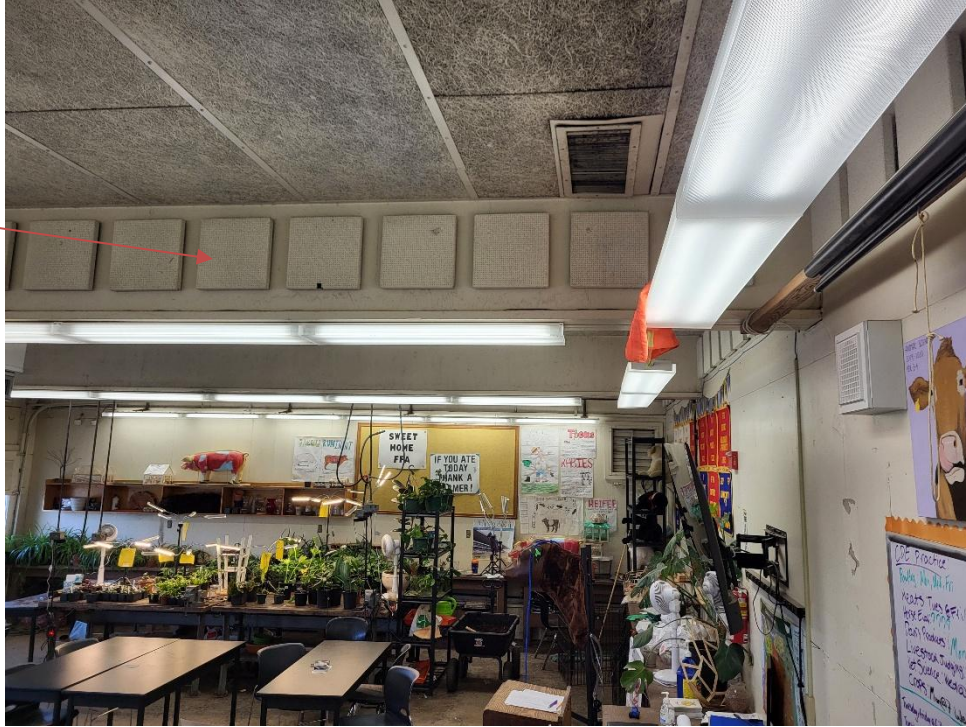
Photo 3 – D1: Brown Mastic Glue Dots (Behind Decorative Tiles) = 2% Chrysotile Asbestos

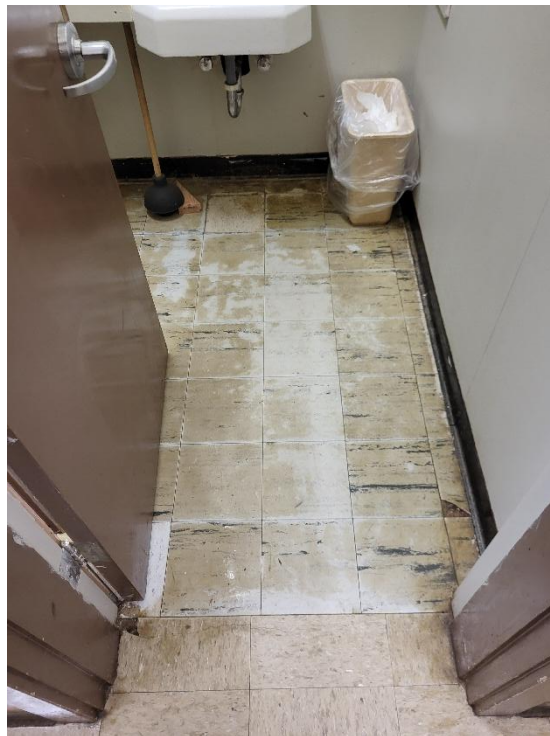
Photo 4 – Wood Shop Single Bathroom: 9"x9" White Vinyl Floor Tiles = 3% Chrysotile Asbestos

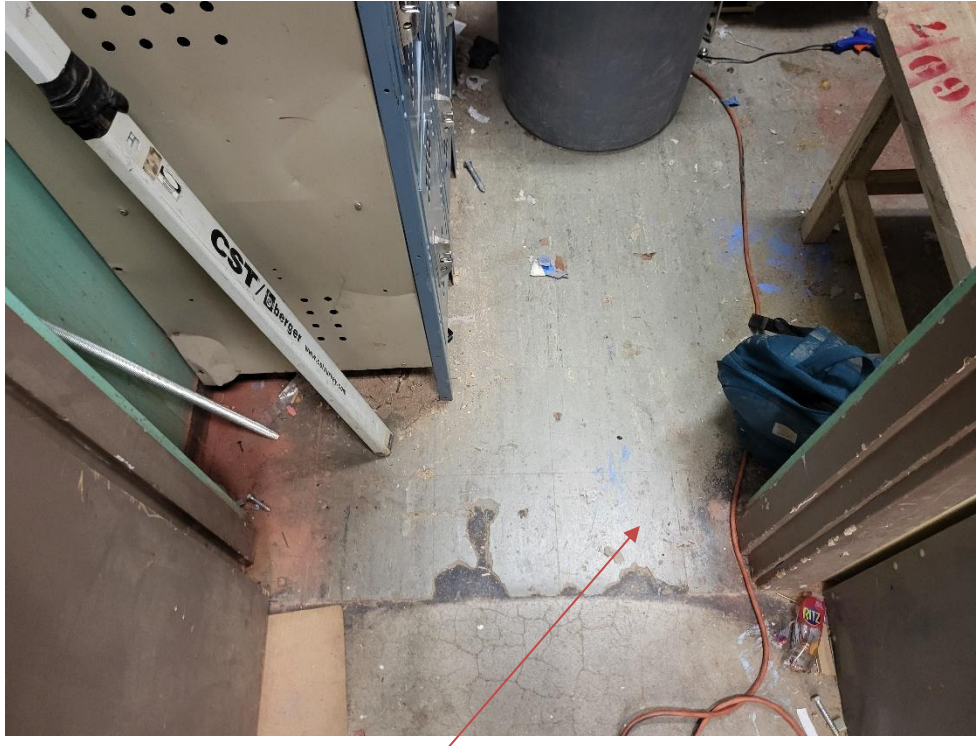
Photo 5 – Wood Shop Locker Room: 9"x9" Blue Vinyl Floor Tiles with Black Mastic = 3-4% Chrysotile Asbestos

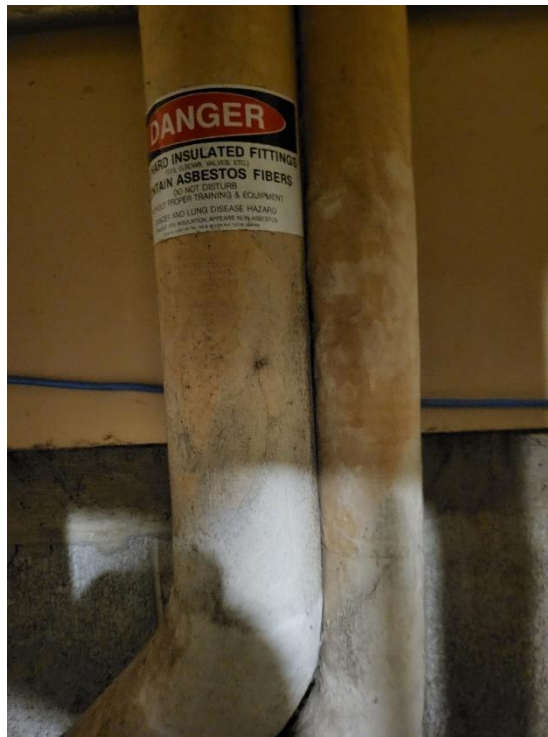
Hard Fittings on insulated pipe runs are labeled as asbestos containing in the Mechanical Rooms of Building B and C and are observed to be present in the interstitial spaces above the drop ceiling in all buildings sampled. Hard Fittings are a plaster style cast, molded onto elbows or tees of piping for insulative purposes. Hard Fittings are friable material and should be removed under a full containment negative pressure enclosure by a certified abatement contractor prior to renovation or disturbance and disposed of per DEQ regulations (OAR 340-032-5650). Hard Fittings may be hidden in walls, chases, or other areas that are inaccessible without selective demolition. If hard fittings are discovered during demolition, particularly in concealed areas, they should be presumed to contain asbestos or sampled to determine the possible presence of asbestos.

Photo 6 – Building B Mechanical Room: Hard Fittings = Asbestos Containing Material

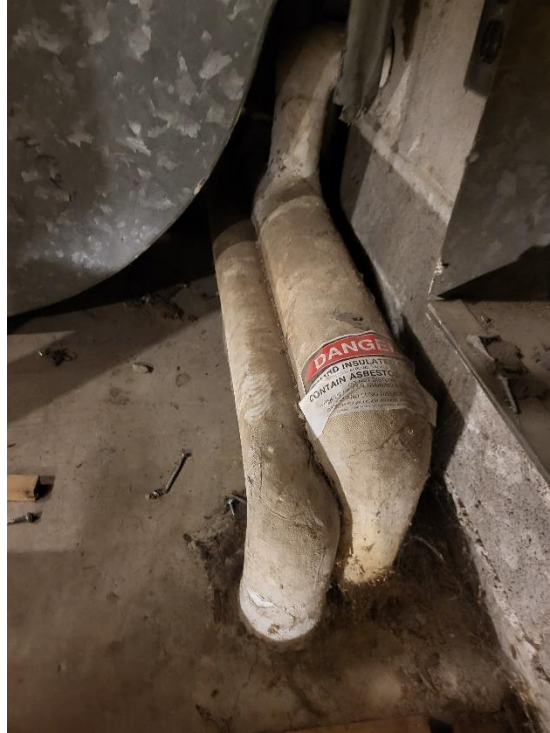
Photo 7 – Building B Mechanical Room: Hard Fittings = Asbestos Containing Material

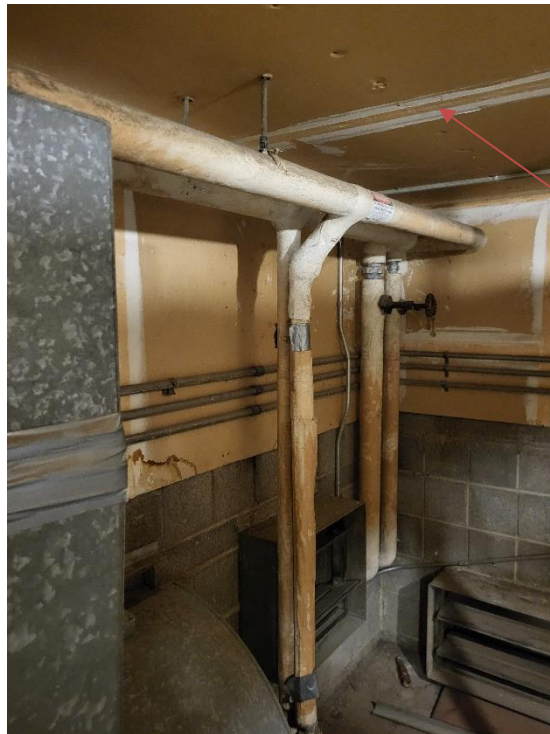
Photo 8 – Building B and C Mechanical Rooms: Gypsum Wallboard with Joint Compound =  
2% Chrysotile Asbestos

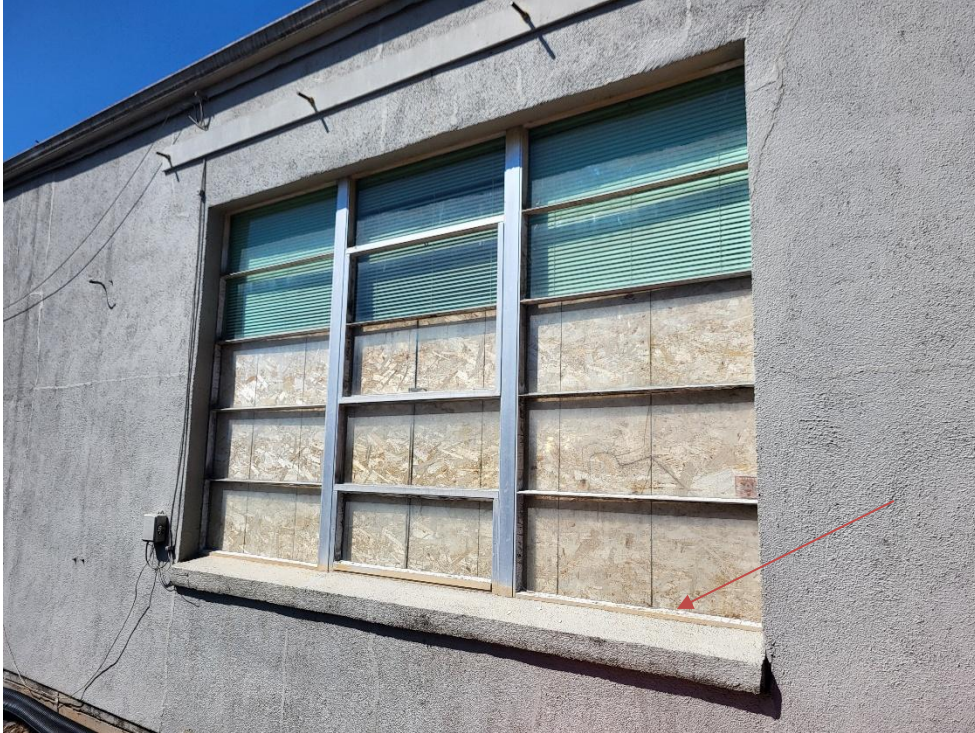
Photo 9 – Wood Shop: Window Glazing = 2% Chrysotile Asbestos

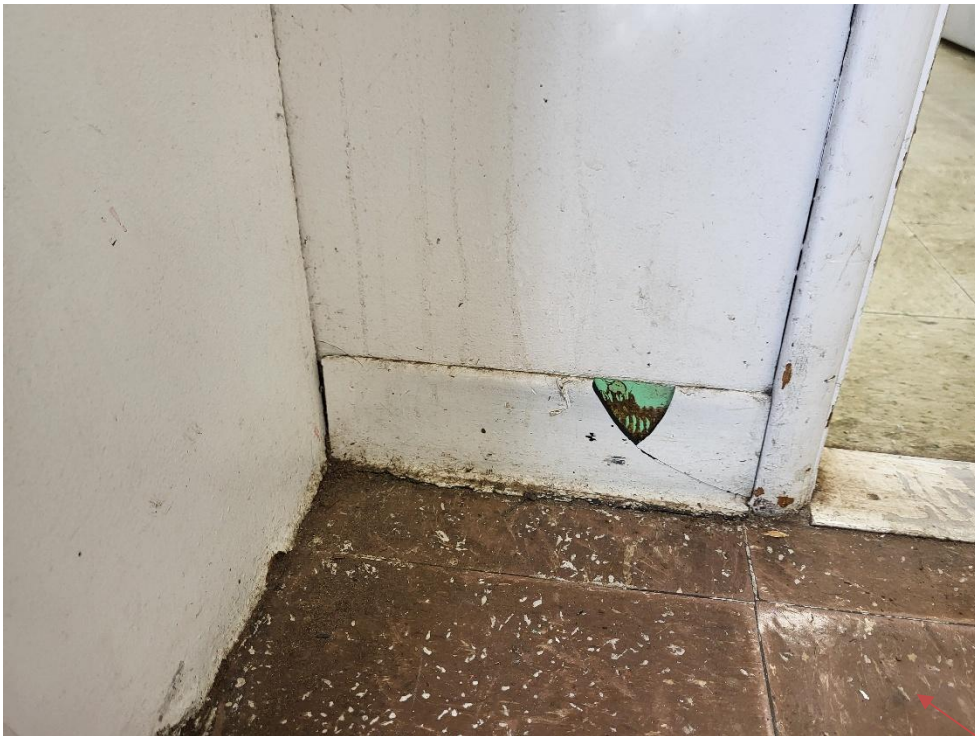
Photo 10 – D4: Red Vinyl Floor Tiles = 3% Chrysotile Asbestos

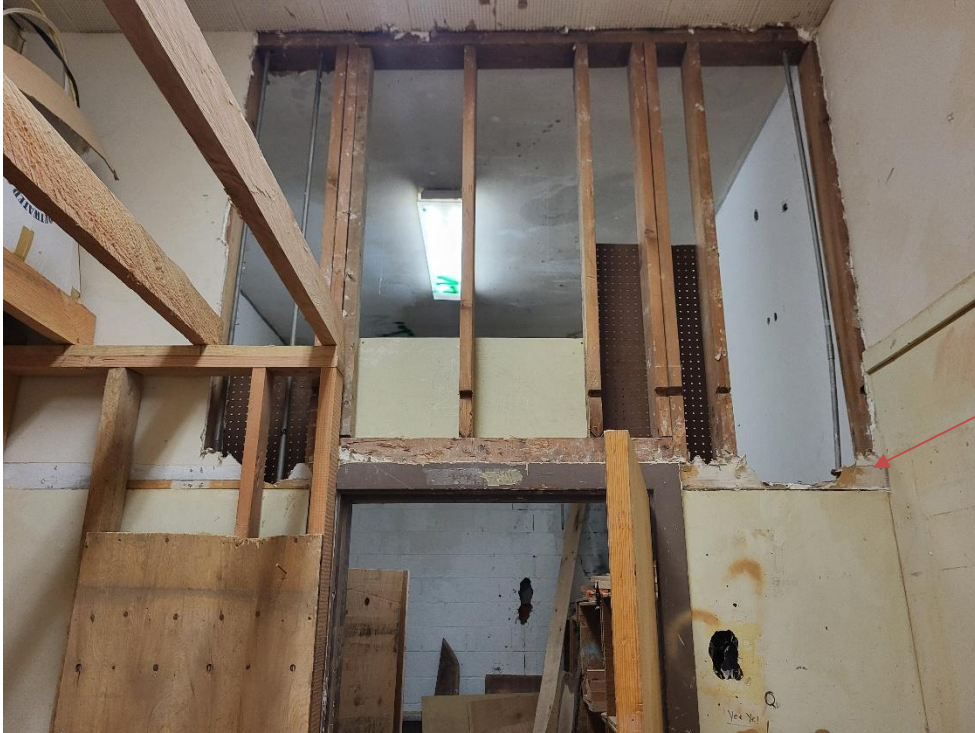
Photo 11 – Wood Shop Storage Room: Gypsum Wallboard with Joint Compound & Black Wall Mastic = 2% Chrysotile Asbestos

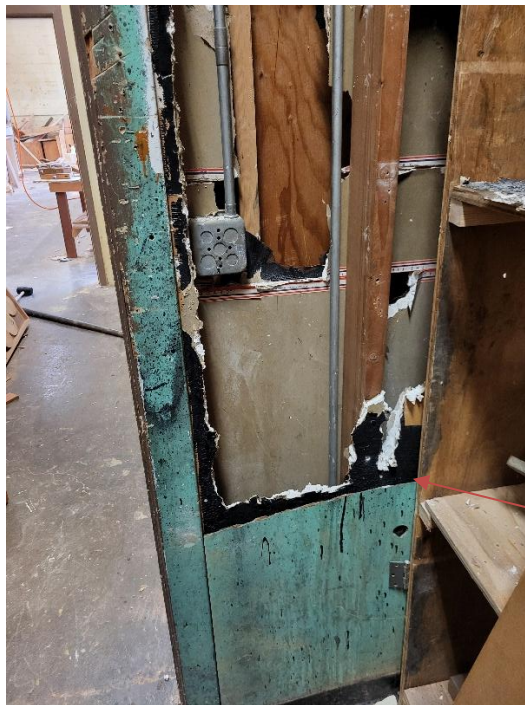
Photo 12 – Wood Shop Storage Room: Gypsum Wallboard with Joint Compound & Black Wall Mastic = 2% Chrysotile Asbestos

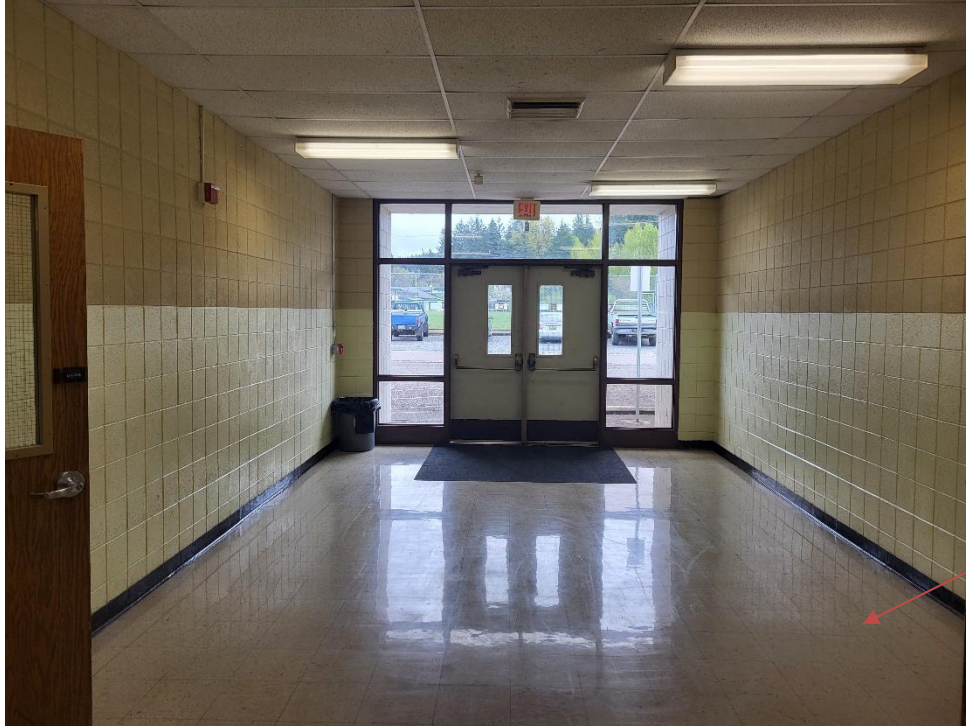
Photo 13 – C Building: Beige 12"x12" Vinyl Floor Tiles with Black Mastic = 3-4% Chrysotile Asbestos

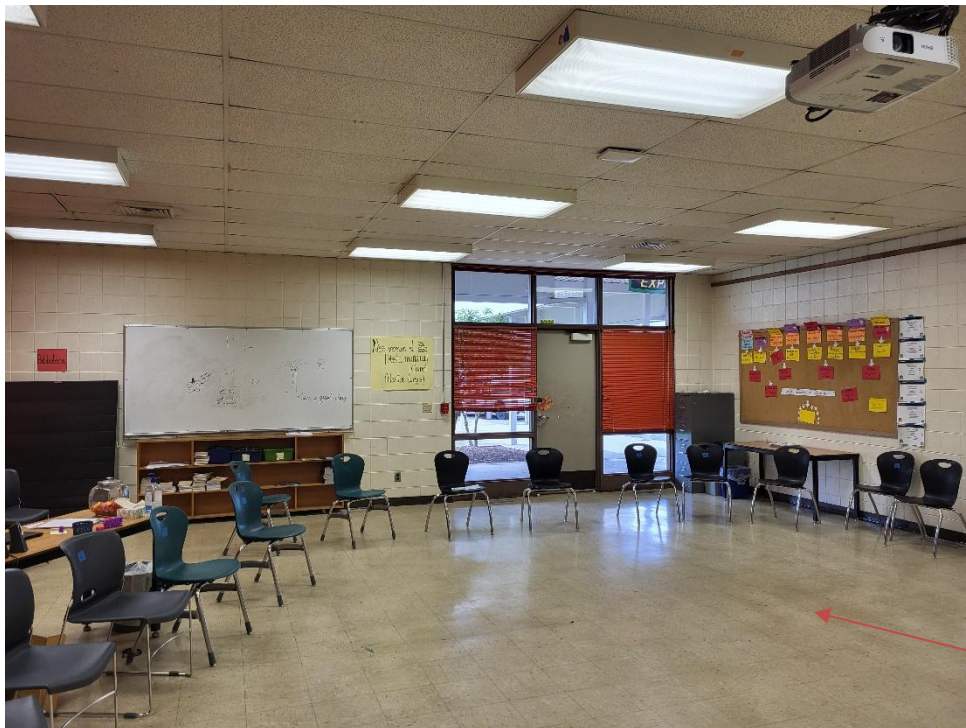
Photo 14 – B Building: Beige 12"x12" Vinyl Floor Tiles with Black Mastic = 2-4% Chrysotile Asbestos

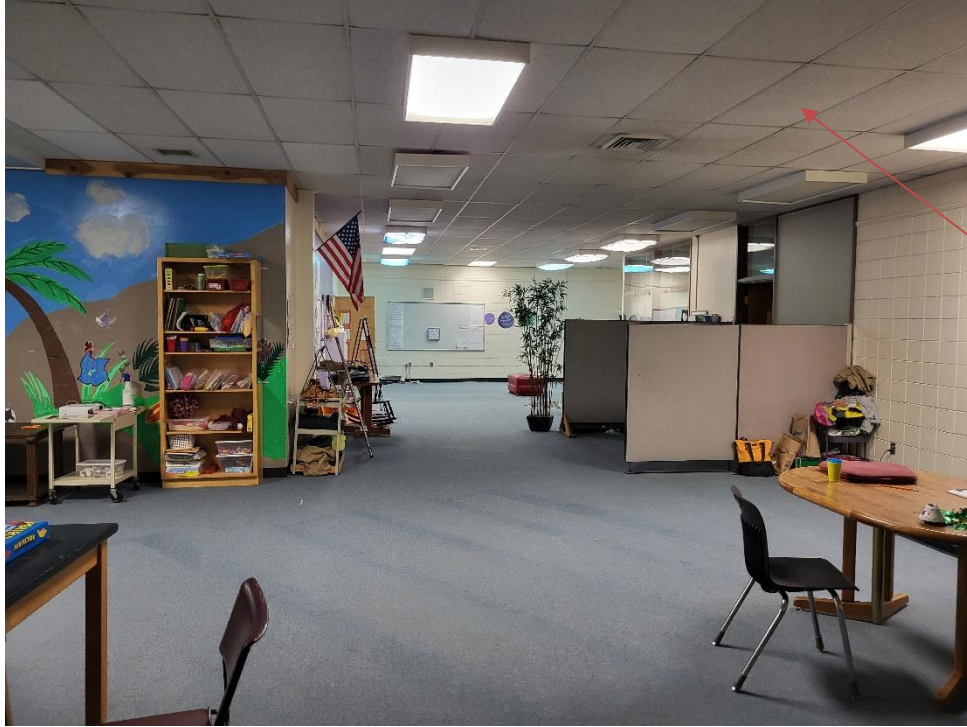
Photo 15 – B Building: 2'x4' Drop Ceiling Tiles = 2% Chrysotile Asbestos

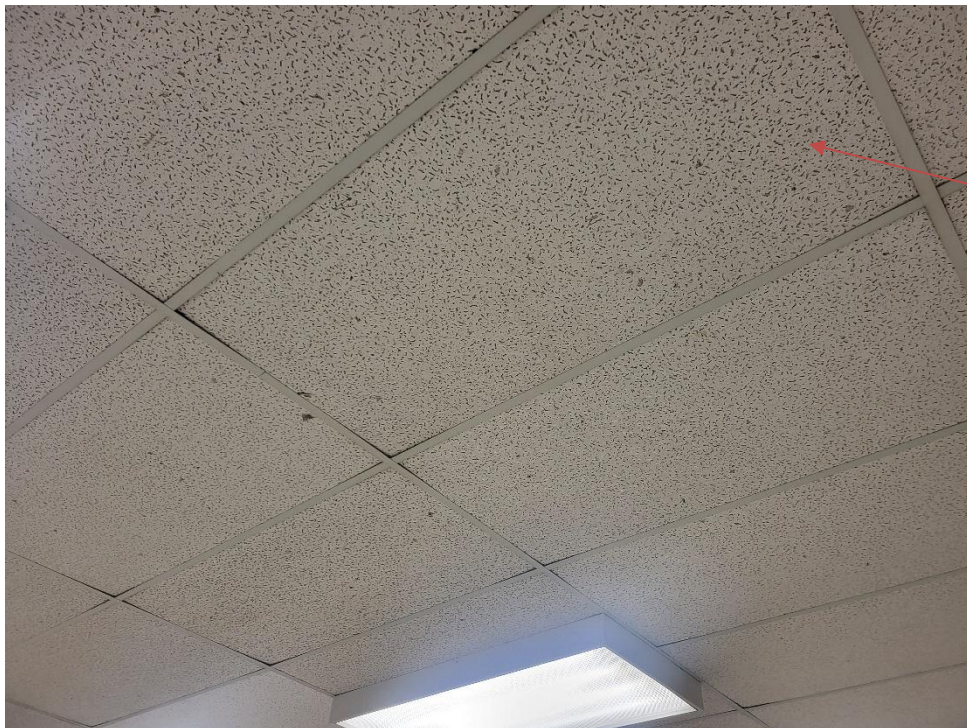
Photo 16 – A Building (East Block): 2'x4' Drop Ceiling Tiles = 2% Chrysotile Asbestos

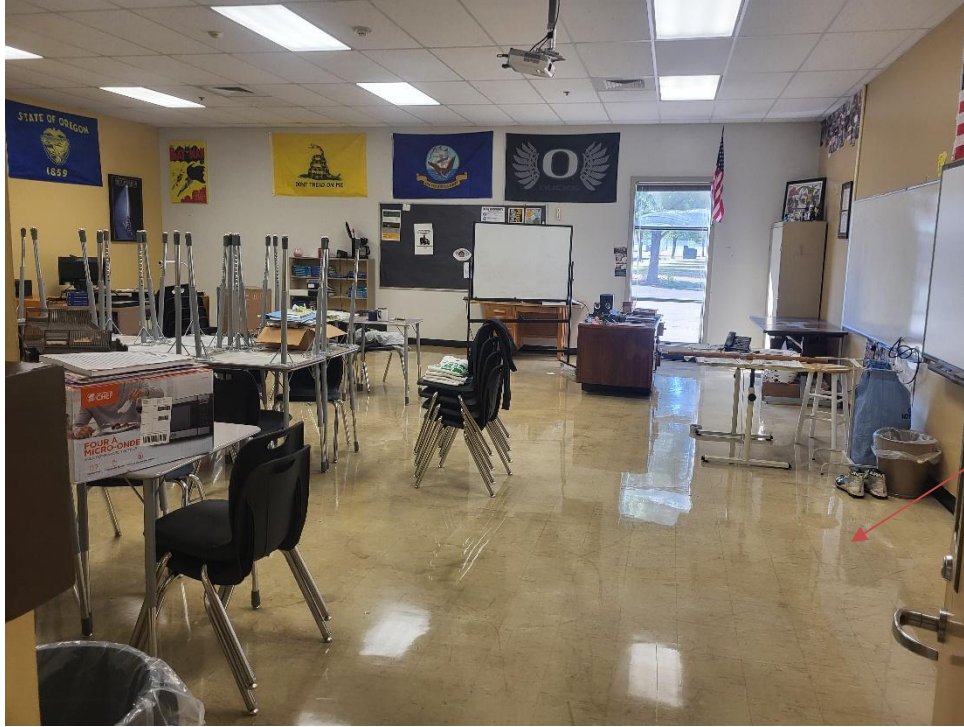
Photo 17 – A16: 9"x9" Vinyl Floor Tiles with Black Mastic = 8% Chrysotile Asbestos

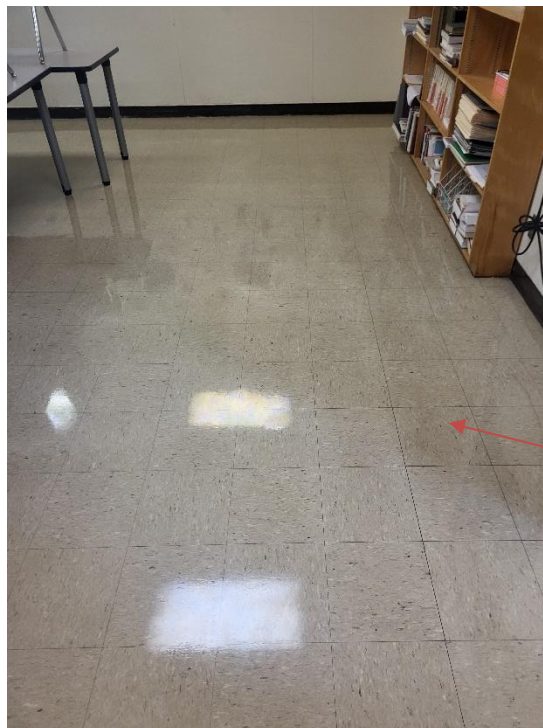
Photo 18 – A24: 9"x9" Vinyl Floor Tiles with Black Mastic = 3-5% Chrysotile Asbestos
